Incident periodical

High Potential Incidents summary
Queensland Mineral Mines & Quarries Inspectorate
August 2020

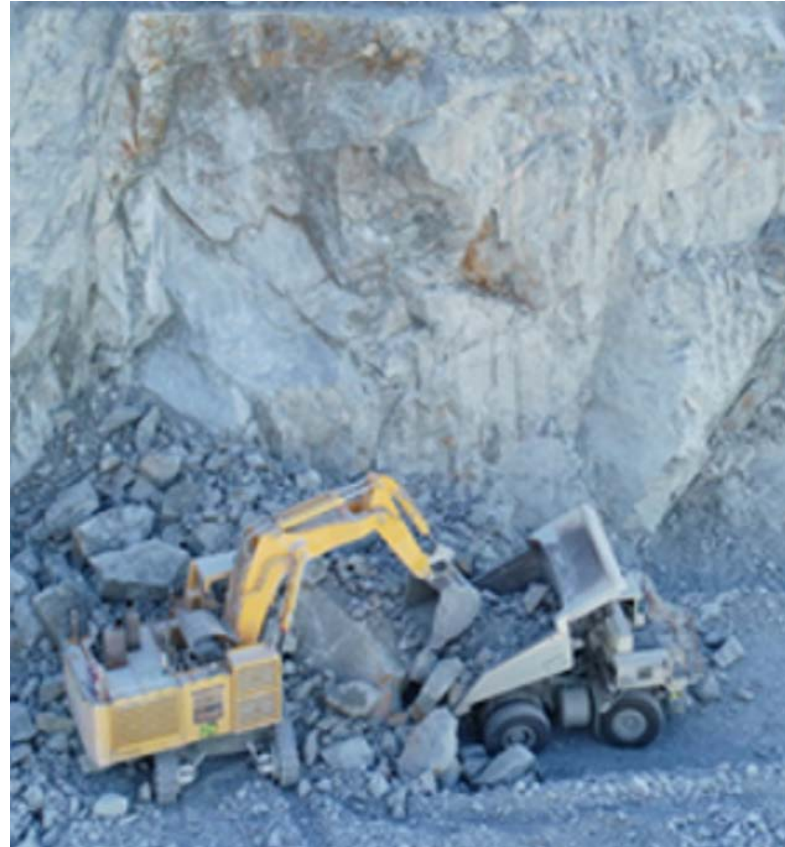
1000 tonne rockfall

On 30 August 2020, an excavator operator had scaled a face and was loading the resultant material into a truck when approximately 1000 tonne of ground fell and partially buried the excavator and the truck.

Displacement was identified in the area a few days earlier by a radar scanner

The operators were uninjured and exited the area without assistance.

The excavator operator has inadvertently removed the key-block that triggered the rockfall.

Several factors may have contributed to this rockfall arising either individually or in combination over time:

- Presplit blasting
- The degradation of the effectiveness of the crest pins
- Water ingress

- Ensure geotechnical input is included in risk assessments carried out by operators when they are going to perform scaling of this nature. [Administration]

- Catch bunds must be constructed based on information about the kinetic energy and predicted location of impact on a barrier. This information must also be used to determine the optimal capacity, size and location of barriers. [Engineering]

- Use engineering methods to reduce the kinetic energy so that catch bunds are effective. These methods include but are not limited to drape meshing, rock deflectors and engineered edge protection. [Engineering]

- Design the pit presplit so that it does not induce instability.[Engineering]
- Use methods of maintaining rock stability in the pit design that will be remain effective for the life of the mine. [Administration]

- A worker within the management structure is responsible to ensure that slope stability is continually reviewed as per the requirements of the Ground Control Management Plan. [Administration]

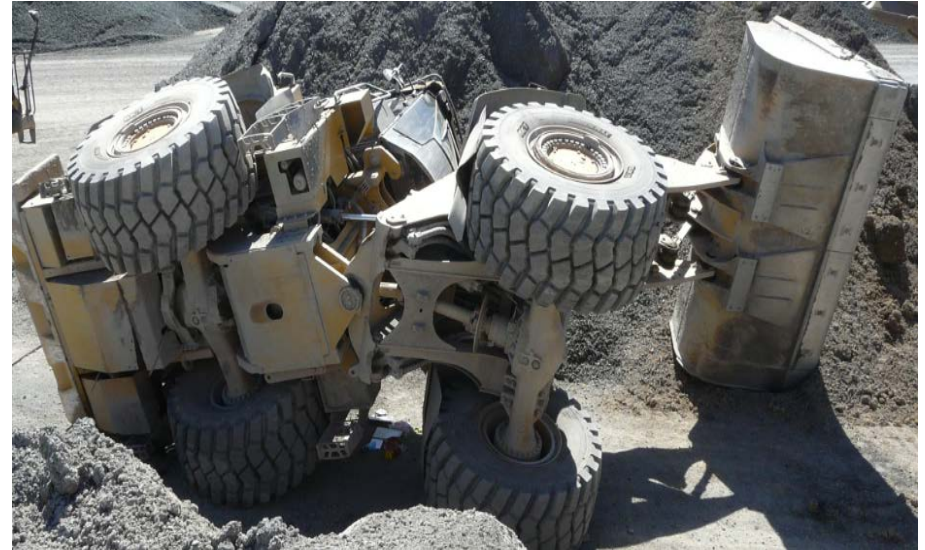
Loader rolls 360 degrees and then onto its side.

On 31 August 2020 a loader was stockpiling road base and travelling up the stockpile ramp nearing the top when it veered to the left, tipped over and rolled down the side of the stockpile.

The investigation by the quarry found that the loaded bucket was raised and the loader was articulated.

The loader operator had been trained and assessed as being competent and had been operating loaders for over 30 years.

The operator was not wearing the seat belt even though he had signed off on the requirement on two recent occasions. The seat belt was fastened and then sat on so that the reminder indicator and recording system were defeated.

It is more than extremely fortunate that the operator only required three stitches to the back of his head.

- Loaders should travel with the bucket low so that good visibility and stability are maintained. [Administration]
- Training and being signed off as being competent should be followed up by periodic observations by supervisors to ensure safe methods of operation and critical safety features are adhered to. [Administration]

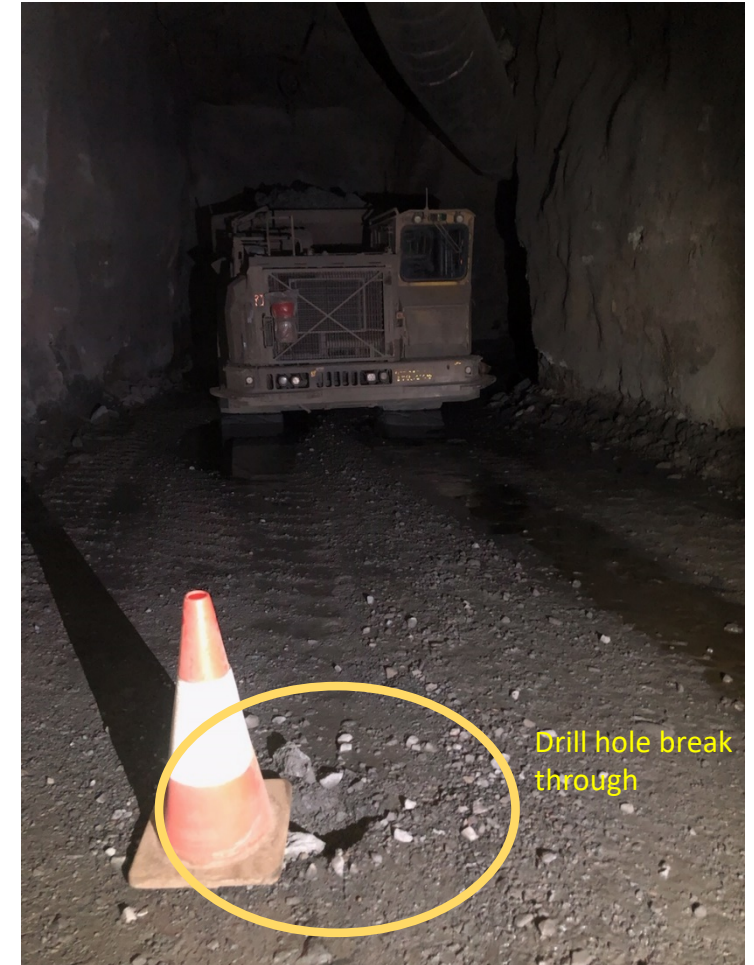
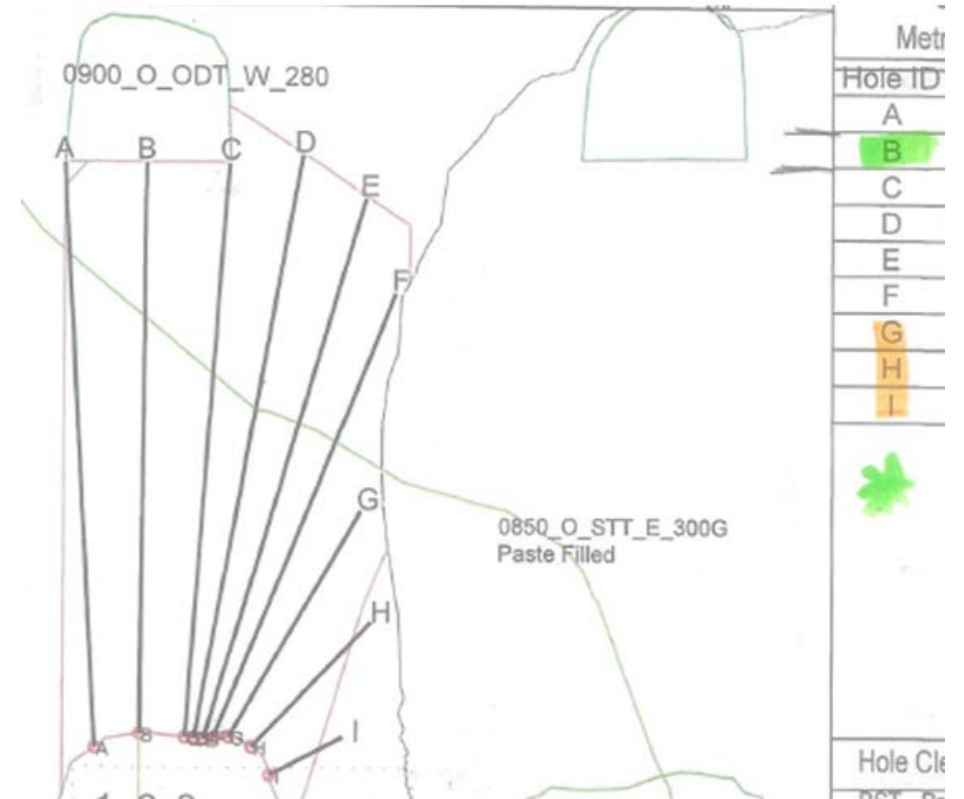
Drill rod breaks through into active mining level

On 26 August 2020 a production uphole was being drilled from one level to an upper level. A truck operator was about to move off when he saw a drill rod break through into the drive 7 metres ahead of his planned travel route.

Mine Technical Services issued a drill plan showing the whole drill pattern, which included breaking through to the upper level. Later the plan was marked up intending to show that only the wall fan holes G, H and I were to be drilled.

The drillers attended the shift prestart meeting but the interaction between the mining on the upper level and the drilling was not raised and the change of plan was missed.

The drillers were working to the drill plan that was not marked up and knew they would break through into the upper level drilling hole B. The drillers thought that the cross shifts had put the barricading in place and did not check it themselves.

- Mine Technical Services to only issue the drill pattern to be drilled. [Administration]
- Interactions between different groups of workers should be flagged and communicated at prestart meetings. [Administration]
- Responsibility for actions to be taken to prevent unintended interactions should be clearly assigned. [Administration]
- The erection and confirmation that barricading is in place is crucial and must be in place even if the drillers do have a correctly marked up plan. [Engineering]
- Barricading should be in place even when there is no planned interaction. [Engineering]
