Incident periodical August 2022

Industry Performance HPIFR and SIFR
Recent High Potential Incidents
Learnings and Recommendations
Queensland Coal Mines Inspectorate

Resources Safety & Health
Queensland

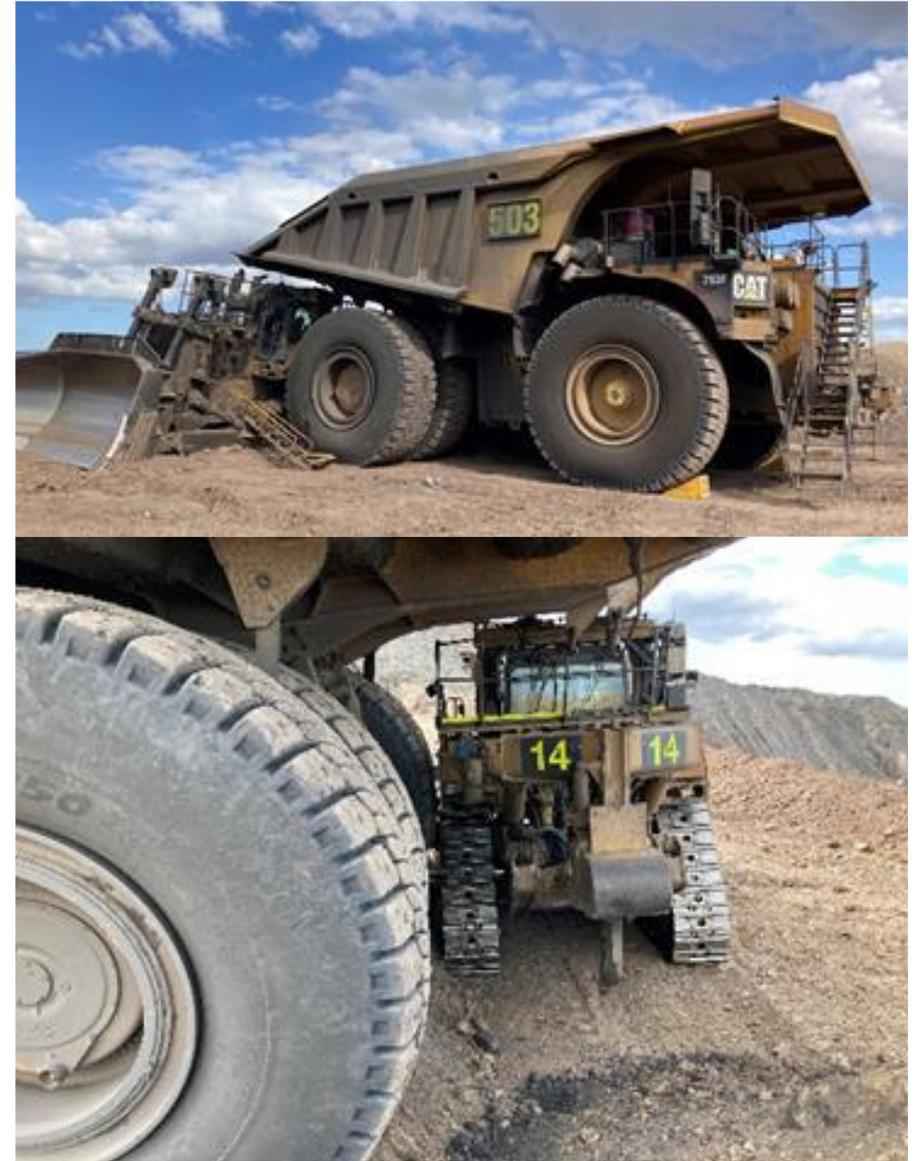
- A dump dozer operator communicated with a rear dump truck operator and directed them to dump the load at the start of the Tip Head (at the V Drain).
- When attempting to raise the tray of the dump truck, the operator was unable to do so.
- They found that the dozer operator had reversed under the tray of the rear dump truck and the tray was hitting the ROP structure on the dozer.
- There were no injuries sustained.

- Implement higher level controls, over and above positive communications, that ensure inadvertent contact between mobile equipment.
- Ensure the mines SHMS provides adequate monitoring for effective application of risk control measures to prevent mobile equipment collisions on dumps.
- Ensure the mines SHMS provides for appropriate action to be taken if the SHMS risk control measures are identified as not effectively applied.

- Should ensure compliance with procedures and processes. This includes consistently monitoring the application of critical controls during dumping operations each shift.
- Take appropriate action if the SHMS risk control measures are identified as not effectively applied.

- Carry out their activities and work in a way that does not expose themselves or someone else to an unacceptable level of risk.
- Must follow site procedures and work instructions.
- If in doubt “STOP” outside of the “No Go Zone”

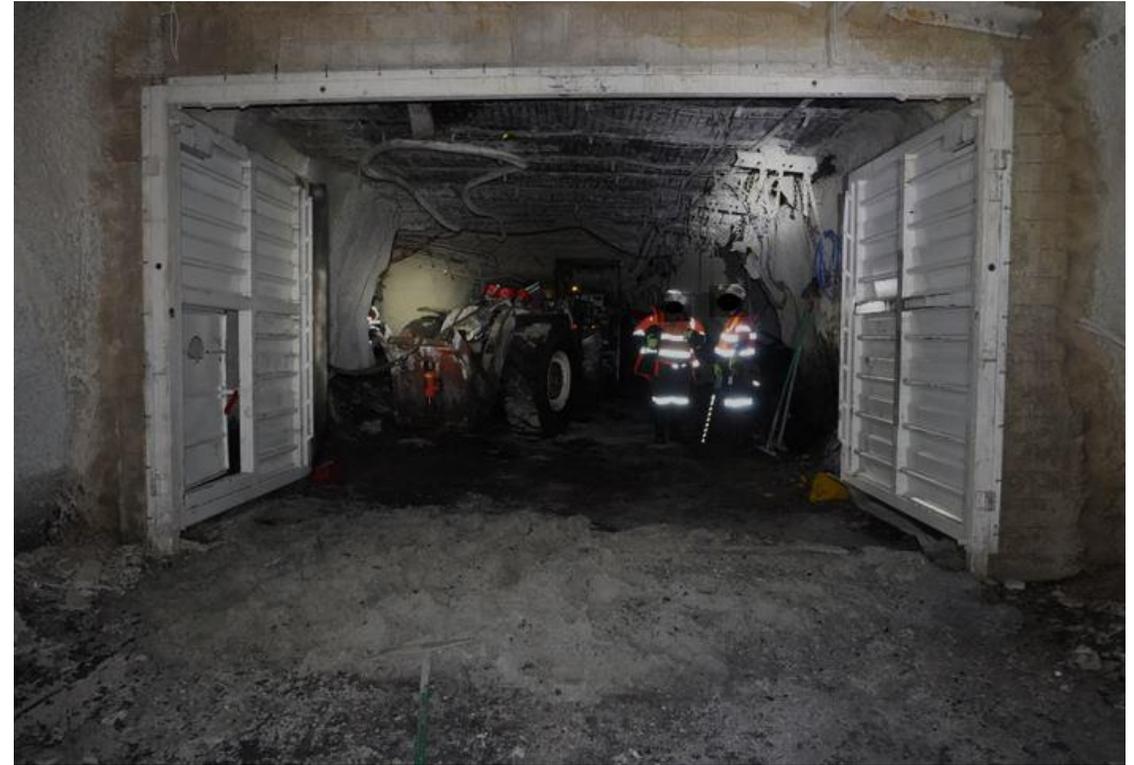
- A ventilation crew were concreting under a set of newly installed regulator machine doors.
- The doors were secured open by chains while the concreting was being performed.
- There was a high ventilation quantity in this roadway.
- A part of the work process was testing the clearance of the doors over the concreted section.
- After testing the left door, it was chained back open.
- While attempting to test the right door, the chain on the left door released and the ventilation closed the left door.
- Control over the right door was lost and it closed also.
- A coal mine workers leg caught between the doors when they closed, resulting in a compound fracture.
- No JRA was developed for the task and the hazard identification process did not identify the high ventilation in the work area as a hazard.
- The points for securing the doors were not fit for purpose.

- Ensure hazard identification and risk control is not being left to the coal mine workers with the least experience and knowledge.
- Ensure all tasks are properly resourced and competently supervised.
- Ensure all equipment and restraining devices are fit for purpose and functional.

- Ensure hazard identification and risk control is not being left to the coal mine workers with the least experience and knowledge.
- Ensure tasks are not allocated before you have confirmed they are properly planned and risk assessed.
- Ensure your workplace inspections identify all hazards
- Confirm CMWs have considered all hazards present and are following relevant procedures.
- Enforce compliance with critical controls to prevent injury

- Ask supervisors and ERZCs' to list out the hazards they have identified during their inspection and job planning
- Carry out their activities and work in accordance with any SOPs, SWIs, JRA/JSAs prepared to manage those hazards.

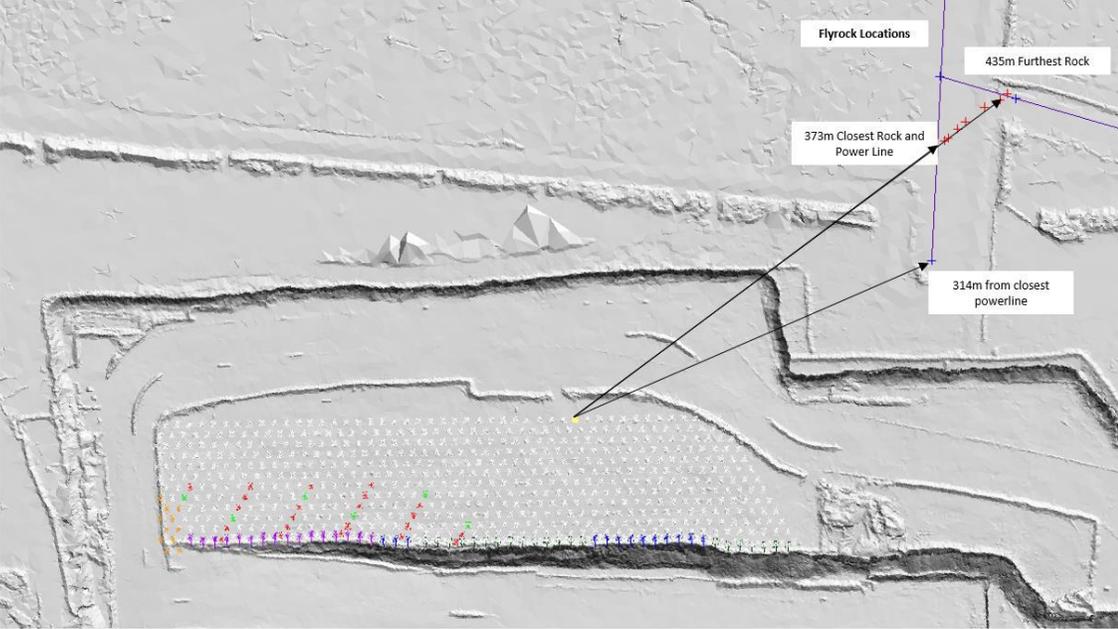
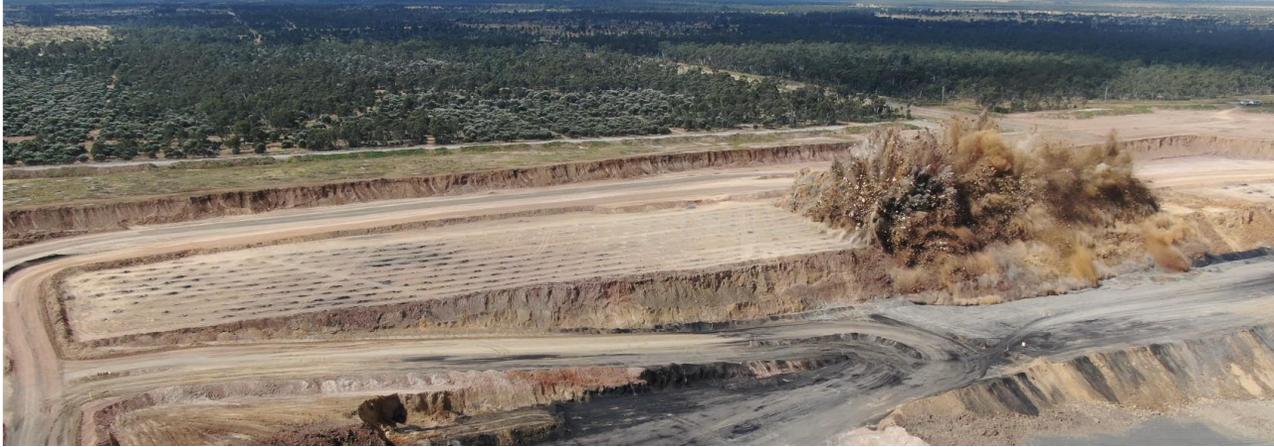
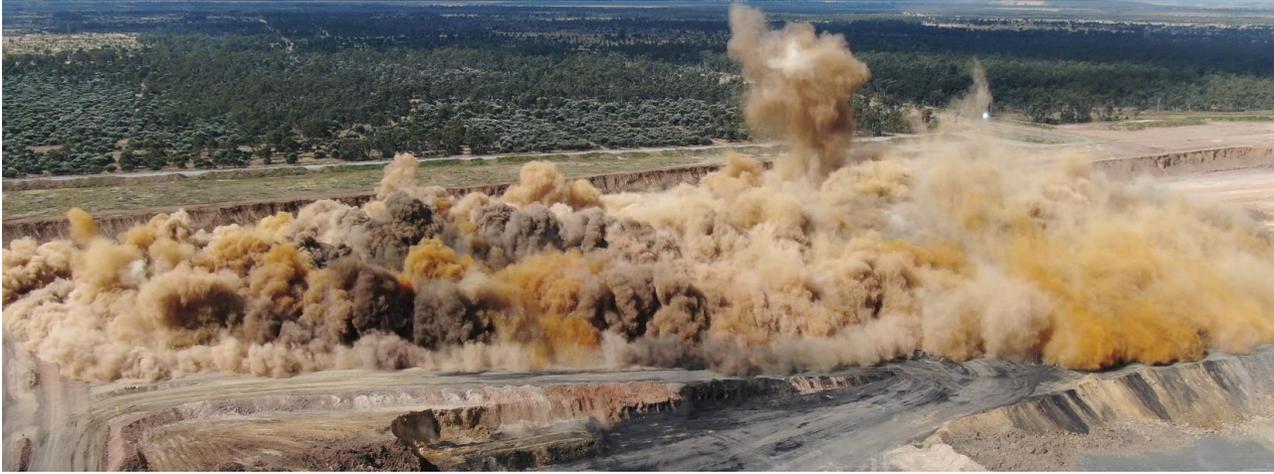
AA114

- During the firing sequence of a shot, the first 100 m of the bench has initiated. The firing sequence then stalled for approximately 4 seconds before recommencing. This resulted in exposing a leading free face for a short time period.
- When initiation recommenced, fly rock was ejected at the rear of the pattern, damaging power lines approximately 370 metres away.
- Power to the mine was interrupted as a result.
- The delay in timing was caused by using two different timing profiles in the blast design and the change was not effectively communicated.
- The resultant shot also produced a significant level of fume (Level 5). The fume dispersed while remaining in the fume exclusion zone (FEZ). No CMW were exposed.

Hole Coordinates
(634376.157, 7521130.821, 192.050)

- Review management of change process and ensure it is effective.
- Review procedures in place for ensuring changes in blast design are effectively managed in accordance with the mines management of change process.
- Ensure processes are in place for effective communication of change and communicated.

- Observe and follow the mines management of change process when changes in blast design are implemented.
- Develop and implement processes for reviewing timing assessments prior to firing.
- Ensure clear communications between technical services and operations.

- Ensure pre firing checklists are undertaken including exclusion zones for fly rock (equipment and people) and fume clouds that may be generated.

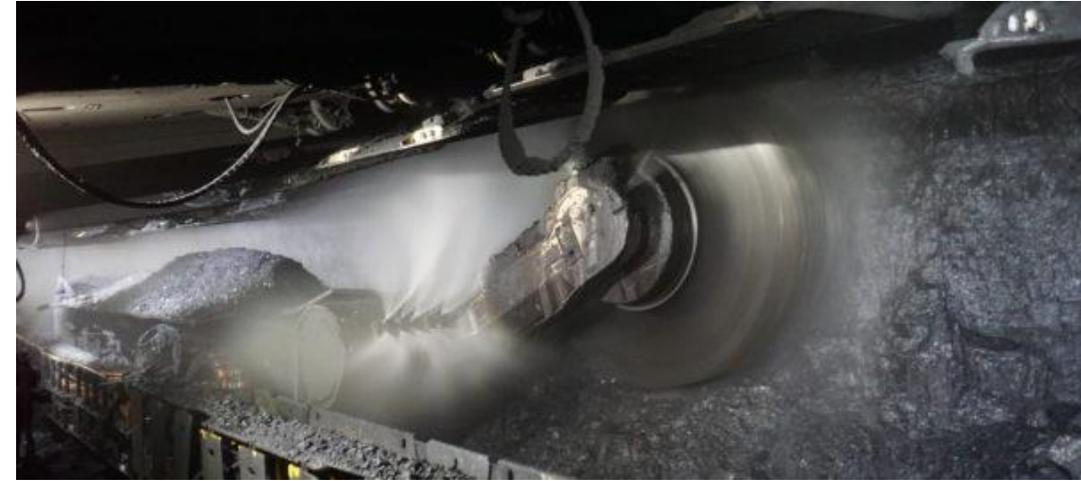
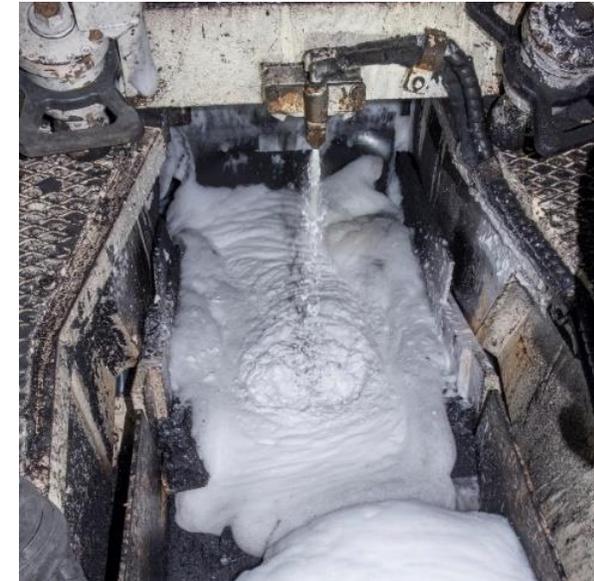
- This trend has reversed during quarter 3 of 2022.
- The increase in exceedances relate to both respirable coal dust (RCD) and respirable crystalline silica (RCS).

- The RCS exceedances are being recorded by mines required to mine through silica rich stone roof or faults for mains development and / or drift construction.

- RCD exceedances are being experienced by mines who have had to perform extensive gas drainage to manage inherent methane in the coal seam. This has resulted in very dry dusty coal and created a potential for greater slabbing on the face. Slabbing is known to generate significant quantities of airborne dust.

- Some mines are experiencing difficulty managing dust during manual operation of shields when mining through zones with roof cavities.

- Ensure plant and equipment is fit for purpose for the conditions being mined.
- Install engineering controls such as dust suppression and scrubbing systems to trap and remove dust.
- Ensure there is a system in place to monitor the condition and effectiveness of dust control systems (e.g. picks, sprays, covers, ventilation devices, foams and surfactants).
- Develop TARPS that respond to changes in control effectiveness, availability of automation and/ or visual dust levels etc.
- Consider the use of real time monitoring devices for establishing no go zones, identifying dust sources and to trigger rotation of workers.

- Ensure operational checks/ inspections of dust controls are conducted at start of shift.
- Monitor conditions throughout shift and respond to changes in accordance with TARPS. This may require increasing rotation frequency, slowing cut rates or changing cutting sequence (eg Bi Di to Uni Di).
- Monitor CMW positioning, rotation of CMWs and respiratory protection compliance.

- Understand and follow no go zones, positioning and crew rotation procedures.
- Ensure sprays are turned on and operating effectively.
- Maintain ventilation systems installed for effective operation (Vent tube advanced)
- Continuously monitor dust conditions and report changes in line with TARPS.
- Ensure respiratory protection is worn for duration of dust exposure period.

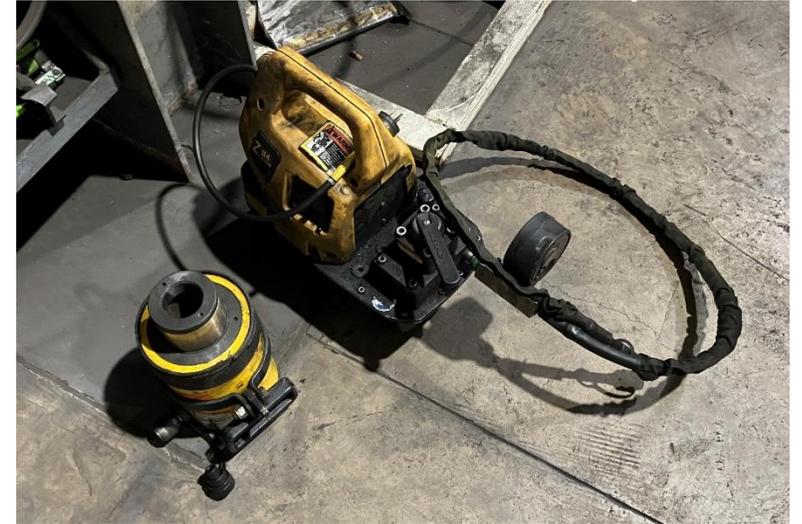
- Two fitters were using high pressure hydraulic tooling to fit an interference-fit coupling to a conveyor gearbox shaft.
- The tooling consisted of a steel bar attached to the shaft; a hollow hydraulic cylinder; strongback; hoses and a hydraulic pump.
- A steel bar was threaded into the end of the shaft and pulled through a hollow hydraulic cylinder and strongback.
- When pressure was applied, the steel bar failed resulting in a piece being projected at significant velocity, impacting with and penetrating the workshop's sheet metal walls.
- There were no CMW in the path of the projectile.
- Investigation revealed that the force generated by the pump had exceeded the capacity of the steel bar.
- In addition, the coupling wasn't pre-heated sufficiently for it to expand enough to be fitted safely.

The hydraulic pump & hollow cylinder from the incident.

- The SHMS effectively addresses the risks associated with hydraulic tooling.
- Resources are available for doing engineering assessments of hydraulic component assemblies.

- An engineering assessment had been completed to match hydraulic components for the specific task at hand.
- A risk assessment had been done and relevant CMWs are familiar with its contents.
- Relevant CMWs are appropriately trained to work with the hydraulic tooling for the task.

- Engineering assessments and risk assessments are understood prior to commencement of the task.
- Hydraulic components used for the task are of matching capacity.
- Pre-heating of interference fitting components are done effectively.

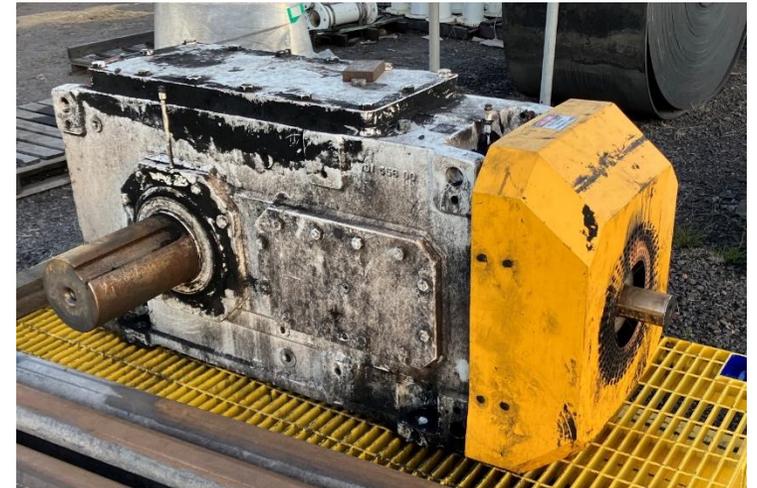
Gearbox similar to the one in the incident
