Monthly periodical

Queensland Mineral Mines & Quarries Inspectorate
July 2021

Mineral Mines & Quarries Inspectorate

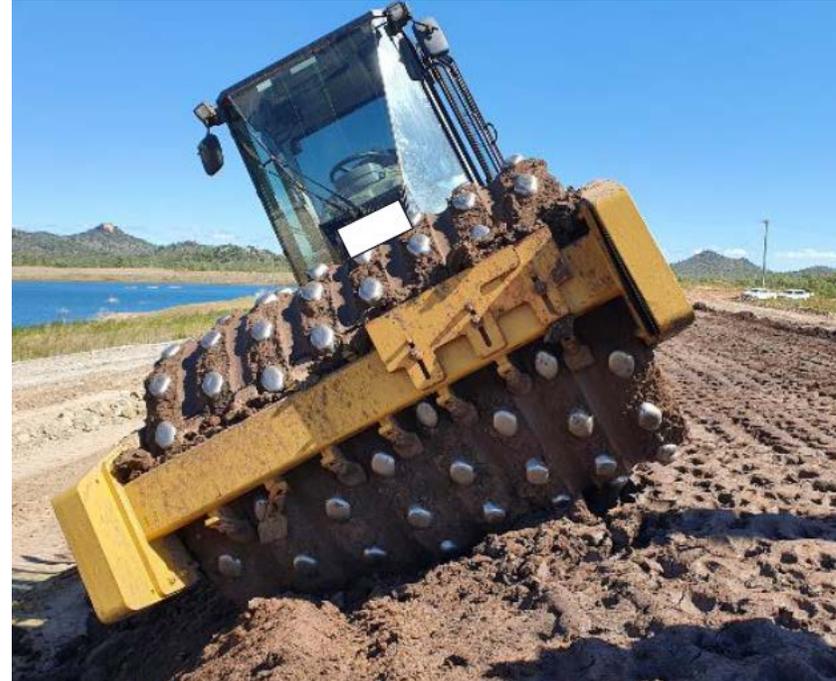
On 4 July 2021 a padfoot roller was reversing along the top of the tailings dam wall when it got too close to the embankment crest which moved under the weight of the machine.

Uncontrolled movement of roller

The operator was reversing near the edge and was intent on finishing the task in a limited timeframe.

The Verification of Competency (VOC) was completed in April 2021 and was relevant for the construction of dam walls. However the contractor's Safe Work Method Statement was generic for all powered plant likely to be used during the project and the hazard of working close to the crest of the embankment was not addressed.

The operator was inexperienced at the time and not under direct supervision.

- The VOC should include the scope of work specifically for the type of plant to be used, as was done in this case. However the VOC should also include : (Administration)
 - Project hazards, such as working on an embankment, are to be kept under control and
 - The understanding of safety critical features of the plant, such as how to test the braking systems.
- The following records must be kept:(Administration)
 - The training undertaken and time spent demonstrating the skills and knowledge to carry out the task safely.
 - The name of the supervisor who supervised workers during this training and their qualifications.
- Tasks should be scheduled as part of project management in order to avoid perceived time pressures on workers. (Administration)

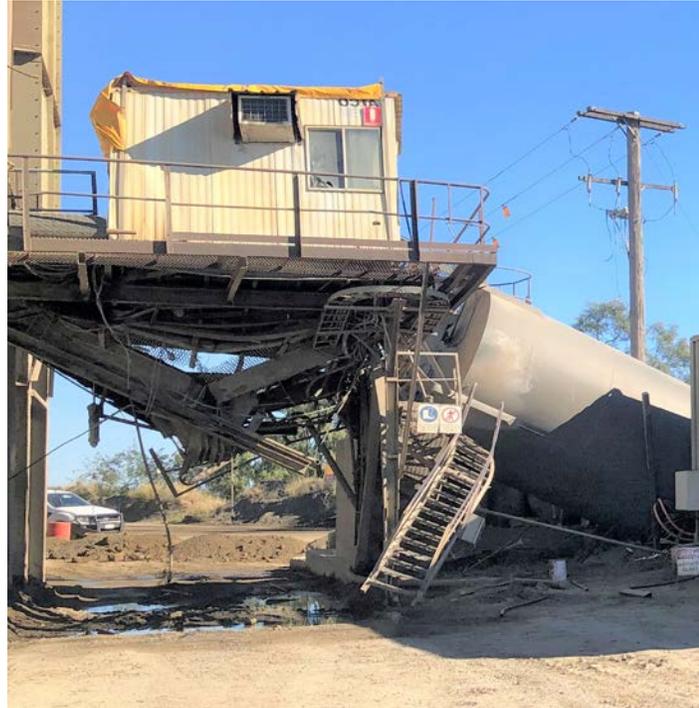
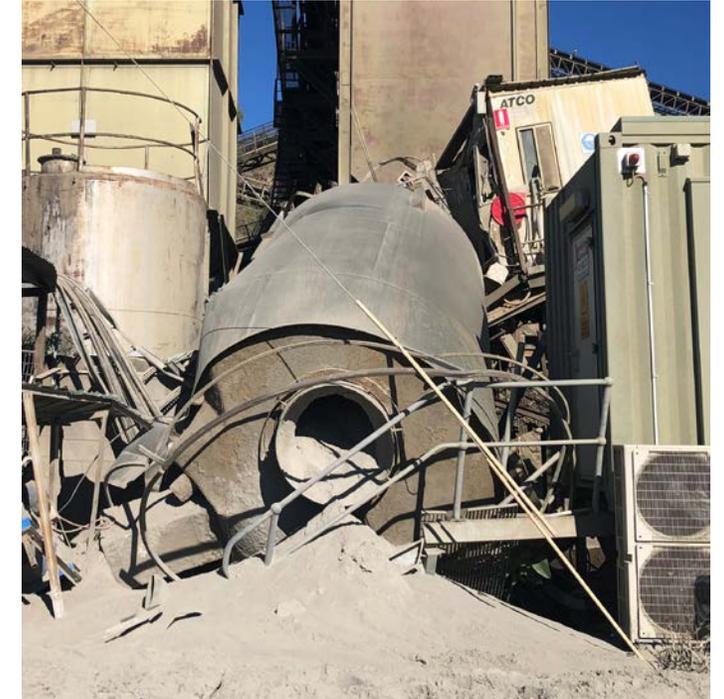
On 26 July 2021 the elevated structure that supported a cement silo failed without any warning and, as it fell it, struck the side of the control room.

Structure supporting cement silo fails.

24 tonne of cement had been delivered into the silo some three hours prior to the incident.

The structure failed in an area that was concealed by a cable tray and was not identified as a problem during the annual visual structural inspections by on-site management.

Corrosion in several other areas was identified in the 2020 visual structural inspection but this did not trigger a follow up external audit.

The last structural audit occurred in 2016 but did not include the support structure for the pug mill.

The design of the support structure was not available for reference during any structural audit.

- Inspections and audits must be scheduled and carried out at a frequency that will ensure the integrity of the plant. (Administration)
- The frequency of inspections and audits must be altered if environmental conditions change. (Administration)
- On-site workers carrying out structural inspections must have the skills and knowledge required. (Administration)
- Structural integrity audits must be carried out by internal or external parties who have recognised qualifications and expertise in this field. (Administration)
- Remedial actions stated in the reports generated by inspections and audits must be carried out within the recommended timeframe. (Administration)
- The design of the structures should be available on site in case anyone has a need to check the structure is being used in accordance with its design.(Administration)
