Incident periodical

High Potential Incidents summary
Queensland Mineral Mines & Quarries Inspectorate
October 2020

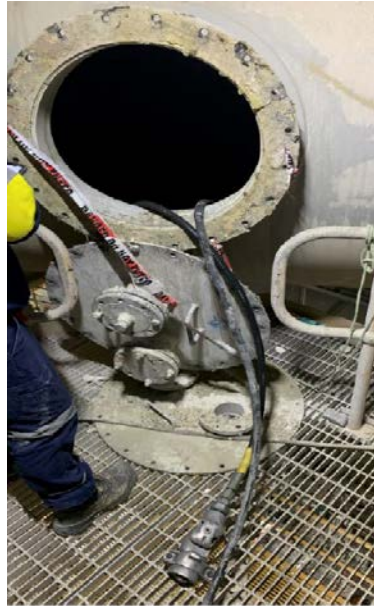
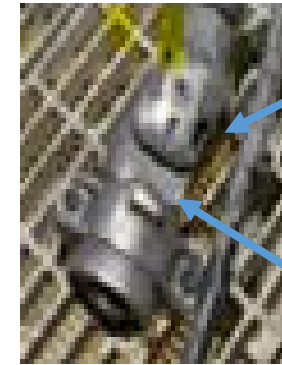
Water at high pressure strikes worker

On 5 October 2020, a tank cleaning head was being used to clean internal pipework when it was ejected through the open hatch. The worker was struck by the high pressure water at 540 bar (7800 psi) from their knee up to their neck causing:

- Minor abrasions/lacerations and swelling to knee
- Pressure marks on neck area.

Cleaning head

Rotating nozzles

Kick plate that provides forward motion when struck by water jets

There were two options for preventing the cleaning head from being ejected from the 1.5 m pipe but neither of them were in place:

- An anti-withdrawal device fitted into the cover which only allows the hose to be fed through it.
- Fitting the cover back in such a way that the remaining gap does not allow it to escape.

The JSA was signed off requiring the cover be put back, this did not happen.

The JSA stated that the reason for putting the cover back on was to prevent flying scale, not to prevent the cleaning head from escaping.

The cleaning head turned around inside the pipe on its own accord as there was no device fitted to prevent this occurring. This turn around is thought to be a rare event,

One of the Life Saving Rules was to use the High Pressure Water Jetting Checklist. This checklist was not used.

JSAs must identify all the foreseeable hazards at each job step, even if they are rare events, so that effective controls can be in place prior to a job commencing.

- The ejection of the high pressure cleaning head through the open hatch must be considered as part of the JSA development. [Administration]
- Hatches and other protective barriers must be in place prior to high pressure cleaning tasks. [Separation]
- The mine management structure must provide for a worker to be appointed who has the responsibilities and competencies to oversee contractor tasks. [Administration]
- Original equipment manufacturer, where possible, should be involved in risk assessments to ensure that all hazards have been identified especially when the plant is of a specialist nature. [Administration]

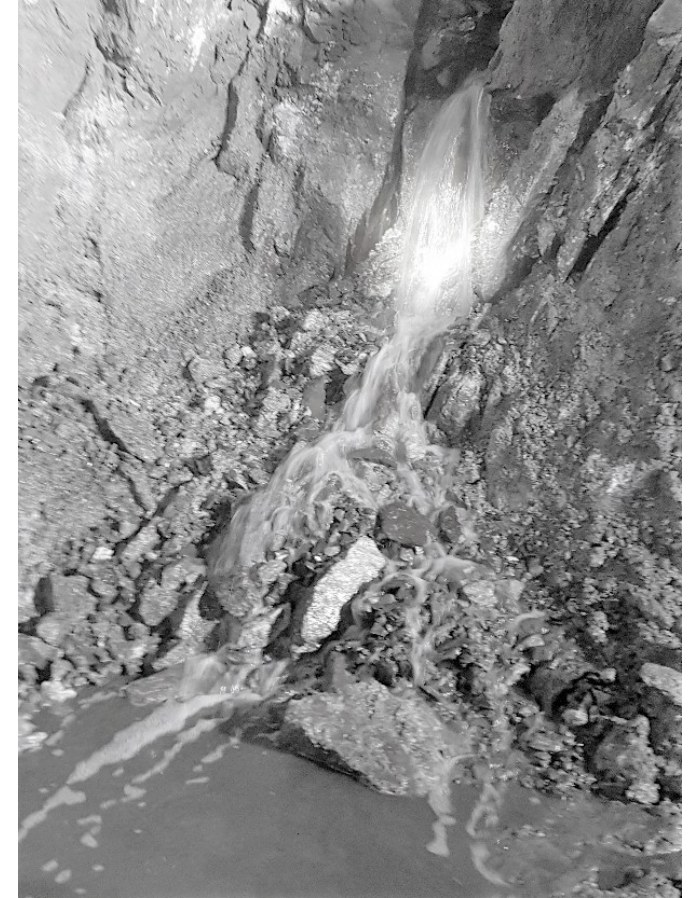
Inrush of water and tailings

On 27 October 2020, a crosscut was blasted underground and after a while water started to seep out from the base of the drive. The photo on the right shows the water flowing out from the shear zone after it had diminished. The flow increased to 50 l/s and included tailings from the adjacent old underground workings.

The inrush then went along the level and down to the charged decline face 60 m below. The water then backed up to the development level. No workers were in the decline at the time but this does not detract from the seriousness of the incident.

Water was encountered previously during the development of the ore drive 20 m above. The water source was believed to be from old workings 50 m below that had been flooded and had a hydraulic head pressure which was able to flow up through a shear zone.

This shear zone was mapped from information from the old workings development and the new development drive 20 m above, but was not added to the design plan of the level below.

The existence of the shear zone was not shared widely with the mining teams by the geology section. As a consequence no probe drilling was identified to check for water during the design or at a meeting prior to taking the development cut.

Access to geological information was restricted to local drives on the server limiting access between geology and engineering.

- A current old workings management plan based upon sound geological data and historical records must be available and communicated to all workers who have been identified as needing to know. Plans must include all variations and critical information on the old workings characteristics. [Administration]
- Controlled drainage of old workings should be undertaken prior to working in proximity. [Elimination]
- Working in proximity to old workings must not be undertaken unless it is known that there is no head of water that can impact on current mining operations. [Administration]
- Changes to a design plan must be communicated widely (where possible face to face) to all workers who have been identified as needing to know. [Administration]

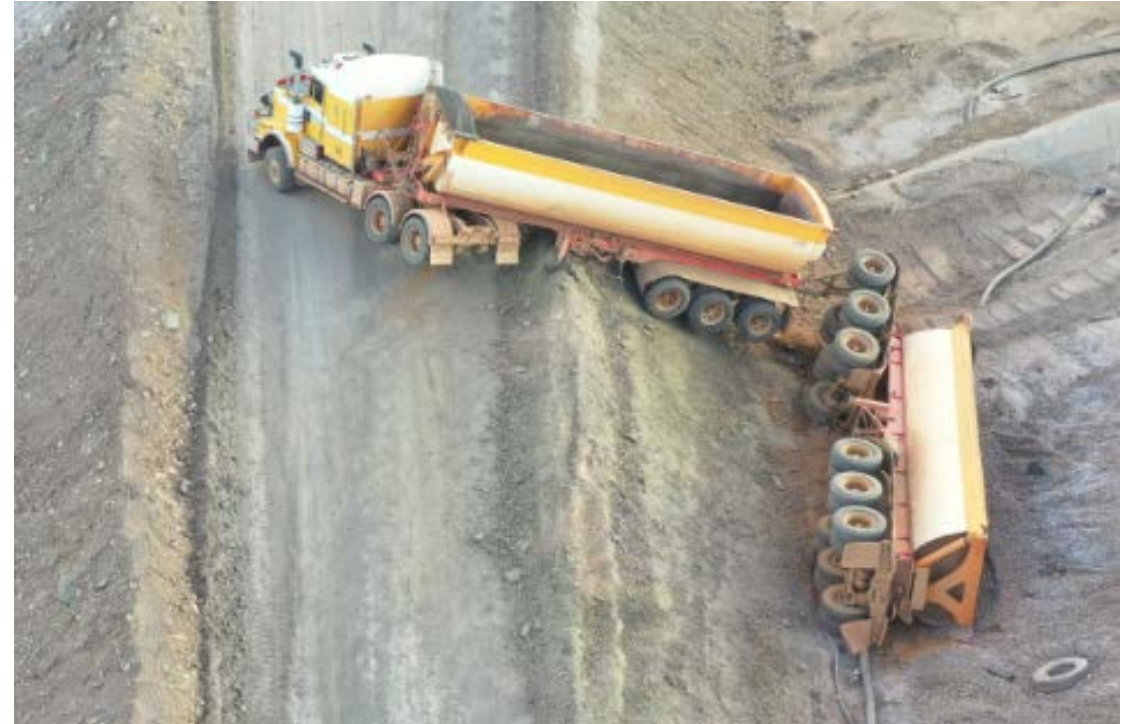
Road train trailer rollover

On 20 October 2020, at the leach pad, the driver of the road train tried to empty the rear trailer first but approximately 25 tonne of material was left in it. The driver then emptied the lead trailer. When the road train then travelled down the exit ramp, it became out of control and the rear trailer went off the side of the haul road dragging the lead trailer with it.

The driver was not injured.

- Emptying the lead trailer first which was against acknowledged procedure.
- Travelling down the ramp with an empty lead trailer and material inside the rear trailer.
- Load distribution lowering braking effectiveness.

- Travelling too fast for the loaded condition.
- In a hurry as it was the last load of the day.
- Fatigue – Allowed to work in excess of the rostered timetable.

- Truck driver training and verification of competencies must include instructions on how to dump and why the rear trailer should be dumped first. [Administration]
- Truck drivers should adhere to routine cycle times at all times. Truck driver must be warned against extra loads at end shifts that compromise the routine cycle times. [Administration]
- The mines management structure must provide for a worker to be appointed who has the responsibilities and competencies to oversee contractor tasks. [Administration]

Note - The cameras on mobile plant should be downloaded on a schedule basis. This will ensure that the camera is working and recording the required data.
