# Incident periodical

High Potential Incidents summary  
Queensland Mineral Mines & Quarries Inspectorate  
November 2020

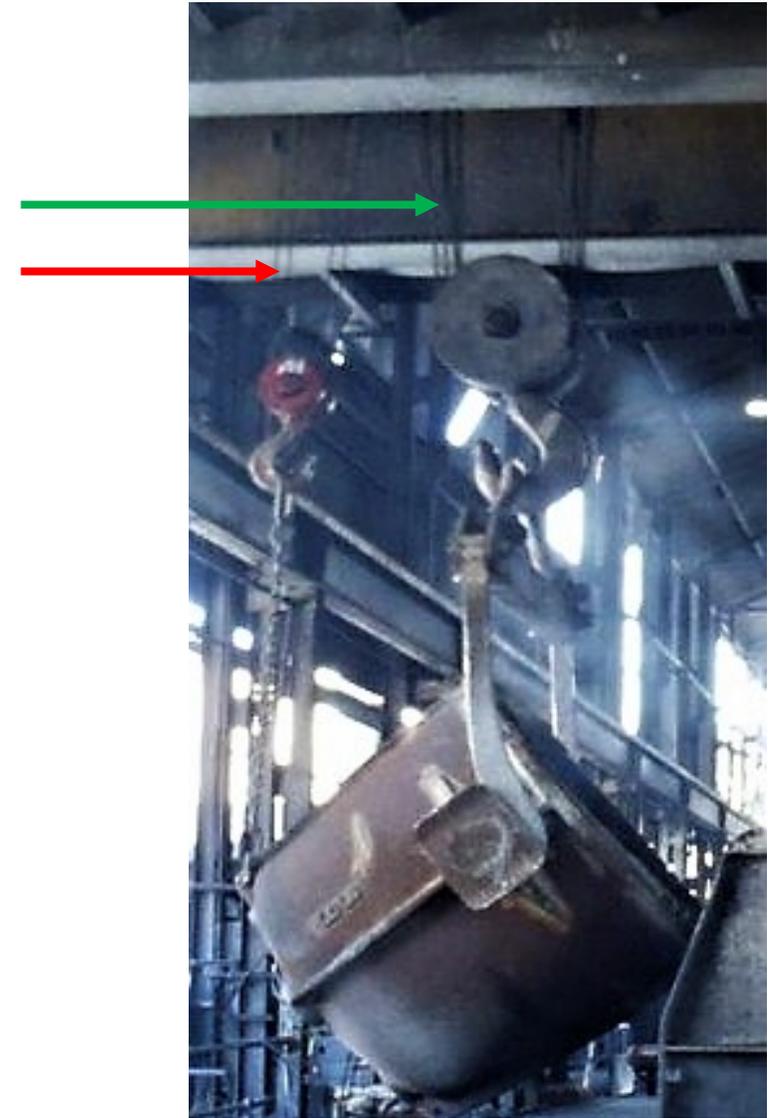
On 13 November 2020, the 10 mm diameter **auxiliary rope** on a overhead gantry crane in a hot metal plant failed during a lift. The auxiliary hoist tilts the pot and allows it to return its vertical position. The **main hoist rope** raises and lowers the pot.

There were no injuries because the incident occurred within an exclusion zone.

- The outcome of an inspection should be to identify whether the rope is still serviceable or should be discarded. [Administration]
- The Monthly Inspection template should provide task outcomes that support whether the rope is still serviceable or should be discarded. [Administration]
- Train and assess workers who are carrying out prestarts and monthly Inspections so that wire ropes are identified as being fit for further use or should be discarded. [Administration]
- Provide pictures of the rope discard criteria at appropriate workplaces for general information. [Administration]

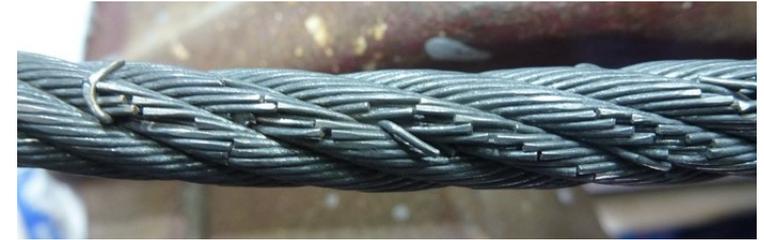
Multiple broken wires were identified after the incident, as seen in the picture.

The monthly inspections did not identify the broken wires which met the discard criteria. The discard criteria was three or more adjacent broken wires in a strand.

- Details only one item referencing the rope which calls for the diameter of the rope to be measured and recorded
- Does not have an item requiring to report on broken wires

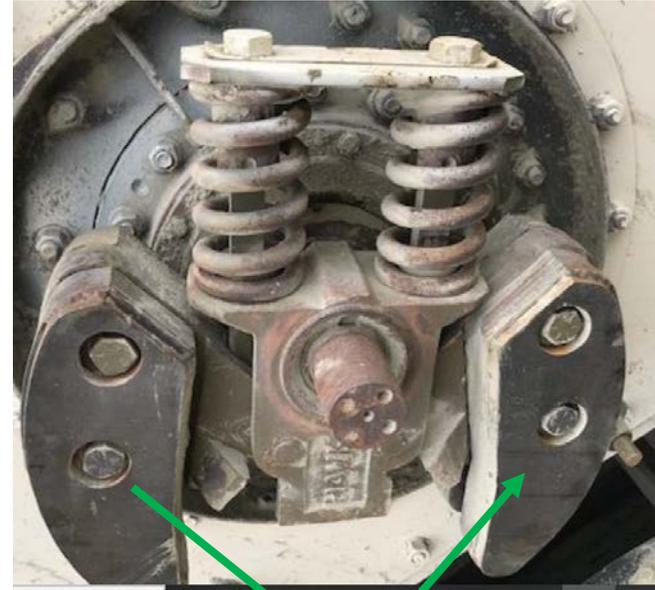
On 10 November 2020, the attachment of a counterweight, which is part of the Spring Controlled Mechanism, failed on the drive side of a triple deck vibrating screen. One of the two bob weights, on the drive side of the screen, broke away from the pin holding it onto the hub attached to the screen shaft

The bob weight weighed approximately 5 kg and went through the counterweight guard.

The two bob weights in place on the non-drive side

- After purchasing second hand plant, mines and quarries should make contact with the original equipment manufacturer to obtain the instructions manuals and information about any design changes. [Administration]

- Nevertheless owners or users of any screens manufactured before 1999 by Hawk Machinery Pty Ltd and fitted with Spring Controlled Mechanisms should contact them if they do not know whether or not the screen is fitted with the upgraded design. [Administration]
- Until the status of the design is known and the upgraded design is installed, an effective exclusion zone should be put in place while the screen is operating. [Separation]

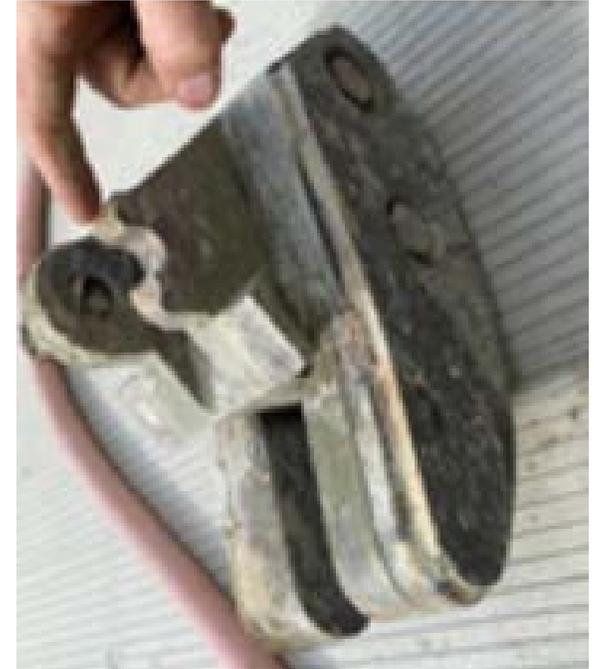
It was known that during the time of the previous ownership before 2005, that there had been failures of the attachment of the bob weights to the hub mounted on the shaft. Subsequently an updated design was introduced. The problem had been that the castings were uneven and the bob weights were not opening an equal distance.

The screen involved in this incident was manufactured in 1998 and had been in storage up until this recent installation.

Note: After 1999 the screens were fitted with fixed counterweights fitted directly onto the shaft.

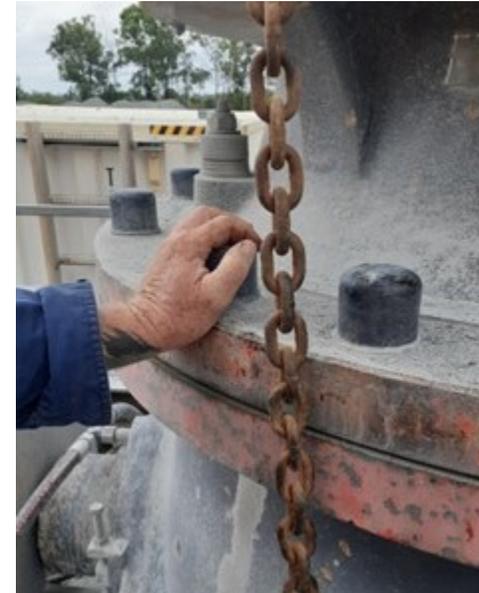
On 20 November 2020, a cone crusher was about to be lifted onto a truck by an excavator in crane mode. As the load was taken up by the four legged chain slings, one of the chain legs trapped the worker's hand against a bolt on the crusher.

This is a static re-enactment

The injured worker had their hand on the cone crusher in anticipation that it would swing once the load was freely suspended.

The injured worker was giving directions to the excavator operator and had not been trained or assessed to perform the role of a dogger.

- A tag line should be attached to loads prior to becoming lifted to prevent it swinging or if it requires guidance when being lowered onto a specific location. [Engineering]
- Workers giving directions to excavator operators, when they are lifting a load, must be trained and assessed as doggers. [Administration]
- Operators of excavators, which are used in crane mode, must be trained and assessed to demonstrate their competency in that role. [Administration]
- Operators of excavators in crane mode should not also be the supervisor at the same time. [Administration]
