# Monthly periodical

Queensland Mineral Mines & Quarries Inspectorate  
February 2021

Mineral Mines & Quarries Inspectorate

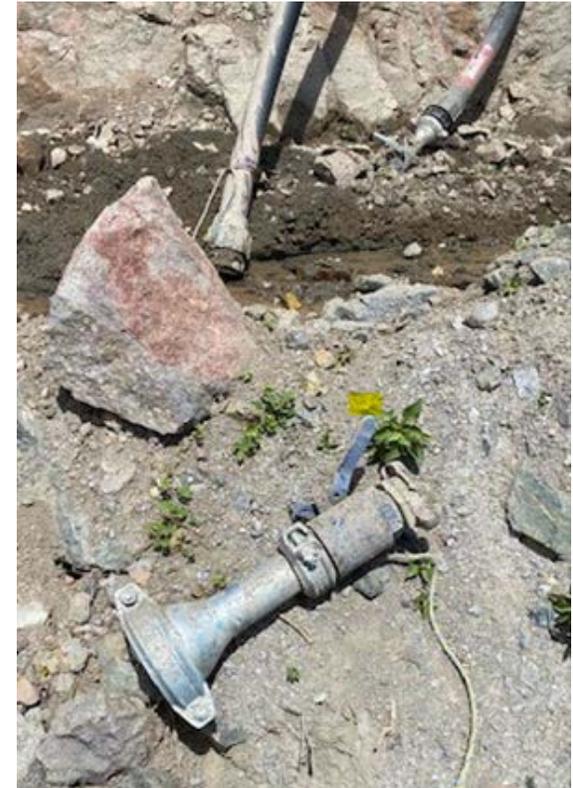
On 7 February 2021, an electrician was dragging a pressurised 110 mm polyurethane pipe from inside a bunded area across the face of the high wall. They were able to do so from outside the bunded area by lassoing the pipe using a hemp rope.

During this activity the handle on the ball valve at the top of the pipe was knocked open allowing the air to discharge from a 100 m length of pipe all the way back to the compressor on top of the high wall. The pipe flayed around breaking off the discharge valve.

There was no single person accountable for the installation of services at this portal and as a consequence this put pressure on the completion date.

Geotechnical reports were not taken into account when the service lines were installed.

As so often happens the workers decided to get on with an unfamiliar job with the best of intentions only to get into trouble. They did not know they were moving a pressurised line and that the pressure could not be reliably contained.

After the service line had been pressurised, the pressure could only be released by opening the valve at the end of the pipe.

The service lines were not restrained.

- Allocate accountability for projects so that timeframes are met without putting pressure on front line workers. (Administration)
- Plan installation of services so that critical components such as isolation and bleed valves can be accessed. (Engineering)
- Recognise situations where the containment of pressure cannot be guaranteed.
- Restrain the air lines to prevent them whipping about when air is being discharged. (Engineering)
- Broadcast internal safety alerts as the mine has done in this case. (Administration)

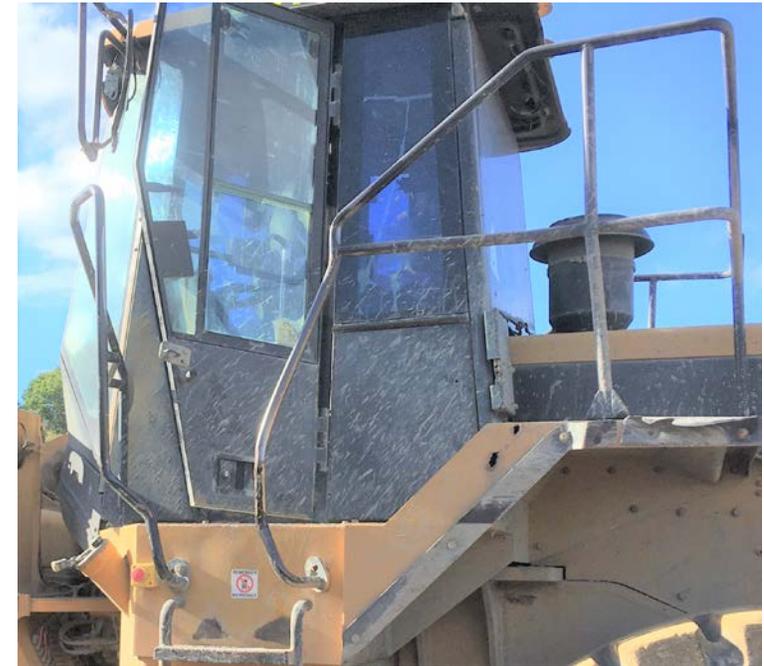
On 17 February 2021, a dump truck was backing up to tip its load at the overburden dump when it collided with the loader that was pushing off.

There was significant damage to the handrails on the loader and the truck had to be moved in order to get the operator out of the cab.

At the start of dayshift there was positive communication by the truck operator and acknowledgement by the loader operator.

The repetitive nature of the task led to complacency later in the day when there was no communication between the truck and the loader operator.

There was a lack of attention to their surroundings by the truck operator

- Only one worker should control the work area, in this circumstance the loader operator. (Administration)
- Where practicable the tipping and pushing off activities should be separated for instance by:
  - Organising the work so that the trucks are not dumping when the loader is pushing off. (Separation)
  - Having a dividing bund down the centre of the dump when there is sufficient space. (Separation)
- Install a portable call point notice where trucks have to call up from. (Administration)
- Everyone on site, particularly supervisors, should be listening to make sure that the practice of positive communication is being followed. (Administration)
- The use of the communication system should be confined to operational matters. (Administration)

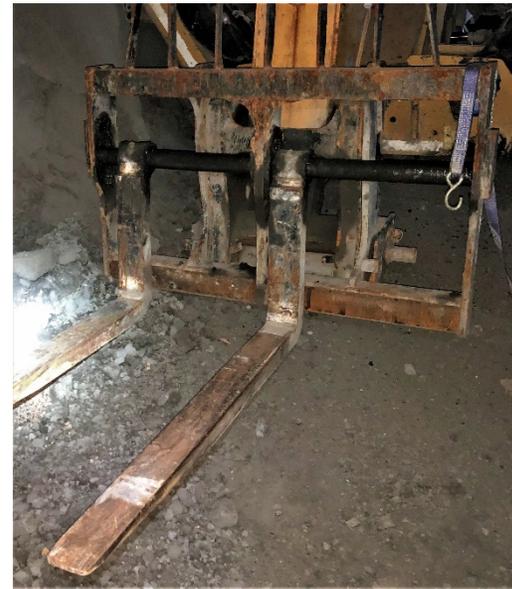
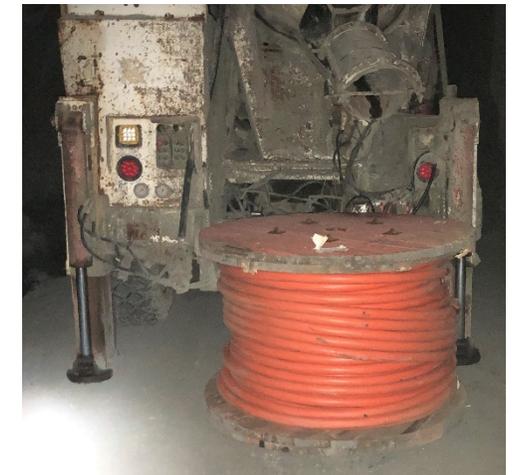
On 23 February 2021, a telehandler was transporting a 1.6 tonne reel of cable down a decline when it was steered into the wall due to a perceived loss of braking. On impact, the load was dislodged and travelled several metres into the back of an agitator truck also going down the decline. There were no injuries.

The telehandler has a toggle switch that can be set to either have the transmission engaged or disengaged when the service brake is applied. When disengaged, this function is used to improve the performance of the implements.

The telehandler was travelling at a speed that required repeated use of the service brake. The toggle switch was set to be disengaged. Therefore there was a loss of engine braking requiring the service brake to do more work.

The operator was aware that the transmission was disengaging when they applied the service brake as they travelled down the decline but continued on. The operator did not fully understand why the transmission was disengaging when the service brake was applied. The operator was unaware that the switch was set to disengage.

The training and assessment package was specific to the telehandler but did not include the functions that enabled the transmission to be disengaged when the service brake was applied.

Irrespective of the lack of retarding effect that was lost due to the transmission being disengaged on application of the service brake, the service brake should still control the telehandler.

The Original Equipment Manufacturer (OEM) states that in avoiding a crush hazard, applying the park brake while travelling will cause unit to stop abruptly and could cause load loss. It also states that to stop the machine in an emergency, apply the park brake. After the incident the park brake failed the static test set out by the OEM in the Service Manual and at prestart.

The service brake passed the static brake test but the mine is still carrying out a thorough investigation to determine if the brakes were as effective as they should have been.

- The outcome of training and assessment must be for workers to know how to safely operate the specific make and model of plant which includes an understanding of all safety critical functions. (Administration)
- Operators must bring plant safely to a stop if they have a concern with braking systems. (Engineering)
- The performance of all braking systems must be understood, maintained and monitored so that it is known they are capable of keeping telehandlers under control under all circumstances. (Engineering)
- Consider whether there is an alternative way of transporting loads down the decline. (Elimination)

Use Australian Standard 2550.19 for telescopic handlers as a source of information to carry out a risk assessment that covers all routine work or one that is job specific.

The risk assessment should at least include:

- how loads are to be secured to the implements (Engineering)
- which way the load should be facing while tramming downhill. (Engineering)
