# Incident periodical

High Potential Incidents – Lessons Learnt  
Queensland Coal Mines Inspectorate  
March 2020

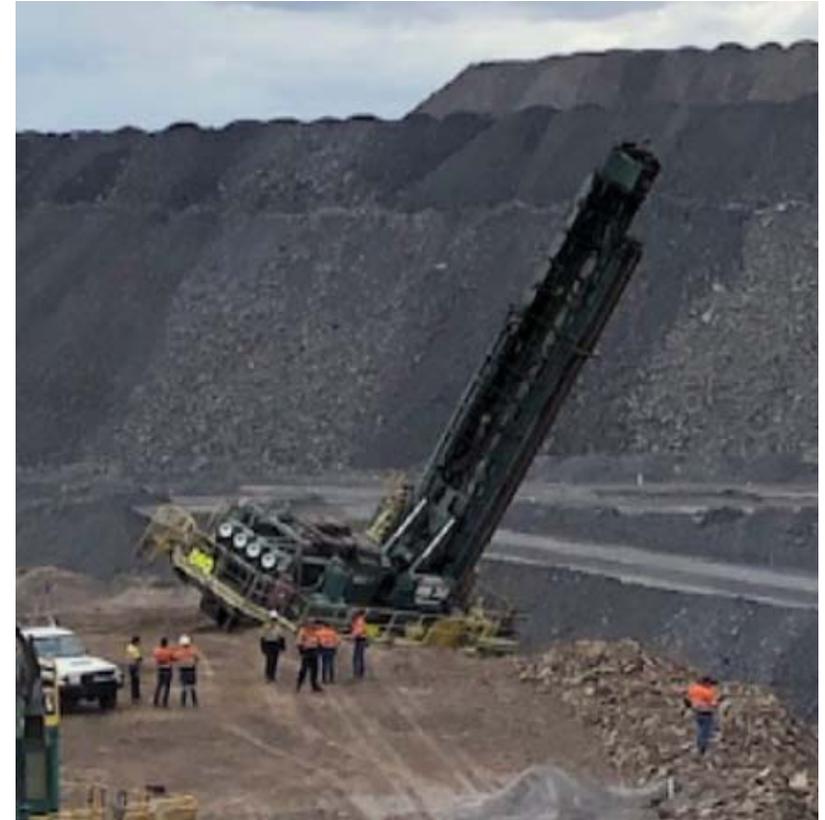
# Slump of drill bench

The advancing endwall slumped beneath a large blast hole drill that was drilling the holes at the edge of the drill pattern.

The drill moved with the slumped material, initially coming to rest at approximately 15 degrees from vertical, allowing the operator to evacuate.

The material continued to move over time, causing the drill to slump further.

Blasted material was pushed into position at the toe to buttress the face and support the drill.

A recovery plan was initiated and the drill was recovered to stable ground.

1. The design of drill patterns must consider the hazards associated with the loss of strata control on drill benches
2. The positioning of drills on the drill pattern must take into account stand off distances and the stability of the bench edge.

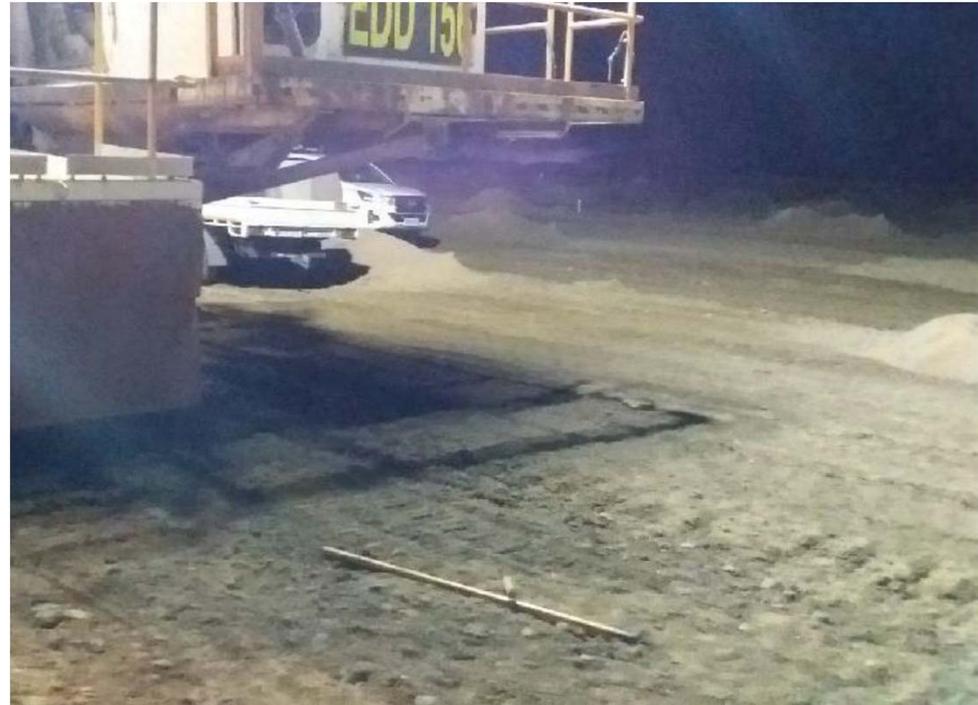
# Structural failure

Blasthole drill rig conducting drilling operations during nightshift.

Drill operator halted operation to investigate movement caught in their peripheral vision.

The operator found two lengths of steel handrail on the ground near the drill deck.

Investigation determined the steel lengths had detached and fallen from the mast.

1. Ensure the mine maintenance practices result in effective inspection and securing of elevated structures that have a drop zone through which coal mine workers pass.
2. Be alert to overhead structures and potential of components to fail.
3. Look up and be Alert

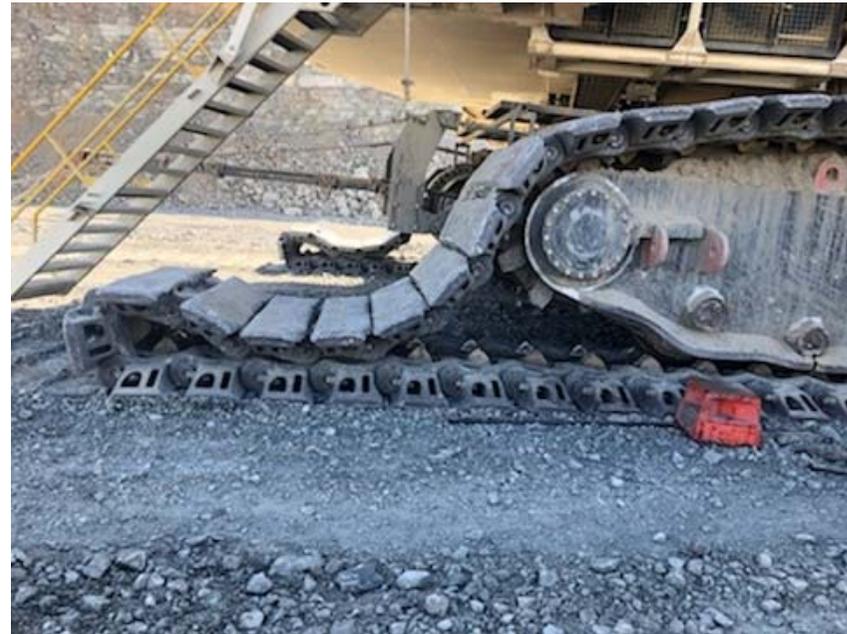
# Failure to manage energy release

When conducting repairs to an electric rope shovel two tasks were undertaken in parallel and impacted the safety of the maintainers.

- the tracks were broken to provide access for maintainers to replace parts.
- A second task required the dipper to be raised and swung 90 degrees.

When the dipper was lifted off the ground, the shovel rolled forward and came off the tracks.

1. Coal mine workers must ensure that isolation of energy is in place and effective before commencing maintenance work.
2. Supervisors must ensure that coal mine workers follow isolation of energy procedures effectively.
3. The SSE must ensure that coal mine workers at the mine are competent in the risk management procedures required for work to be conducted at an acceptable level of risk.

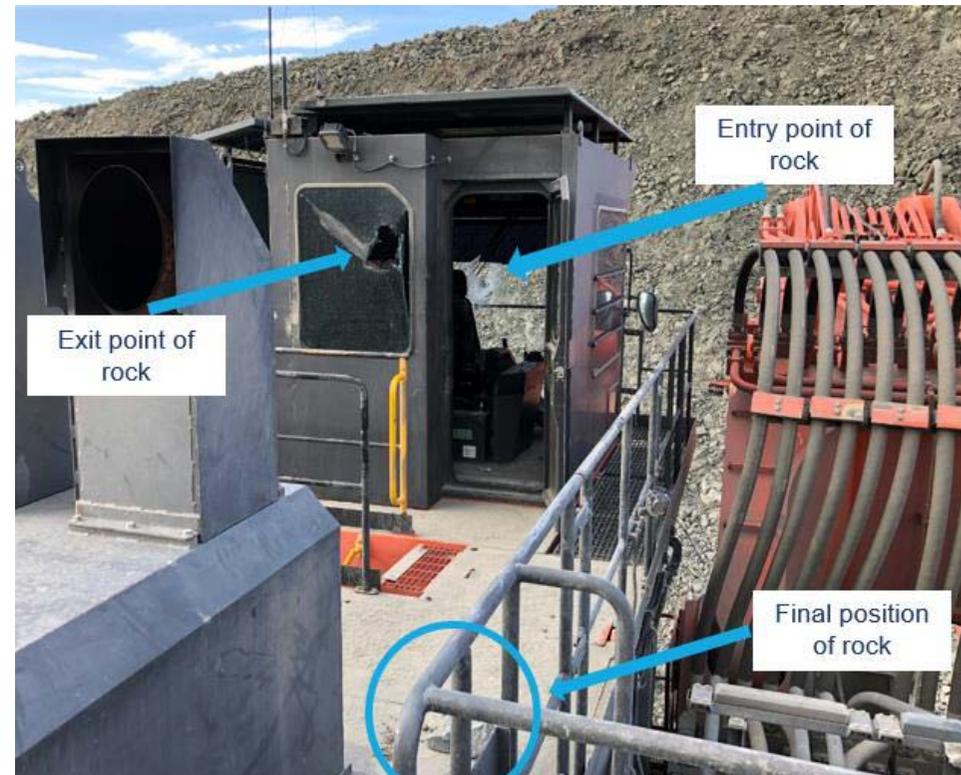
# Failure to manage energy release

An excavator operator has placed the first bucket load of rock in a truck tray and slewed for the next pass. A rock has bounced off the side of the rear dump tray and come through the front windscreen, struck the cabin roof, and exited via the rear windscreen. The operator had superficial physical injuries from the broken glass.

1. Excavator operators should be protected from the entry of objects into the operator's cabin via windows and windscreens.
2. Site senior executives should ensure that plant design ensures effective hard barriers are placed in the line of fire between coal mine workers and moving objects.
