Resources Safety and Health Newsflash

An early report about an incident that may require action at your mine

Mobile Plant – Access Entrapment

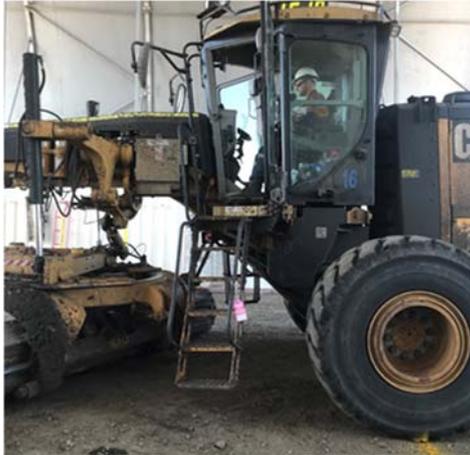
A High Potential Incident involving machine access occurred at a mine in the northern Bowen Basin on the 28th March 2020. A maintainer was completing post service checks whilst seated in a grader with the cabin door open. The grader was fitted with a dynamic rotating access ladder (refer Fig 1 & 2). On completion of testing, the maintainer has initiated a machine shutdown; and the ladder has activated swinging up. The maintainer was caught half out of the cabin when the ladder struck his foot pinning him to the walkway. In this incident, the maintainer was able to activate the emergency stop.

Fig 1: Grader showing ladder

A number of recently reported incidents involving machine access systems have resulted in worker fatalities and others suffering serious injuries. It is recommended that;

- Risk assessments and controls for machine access systems be reviewed. Risk assessment for all machine access systems and machine configurations must be assessed.

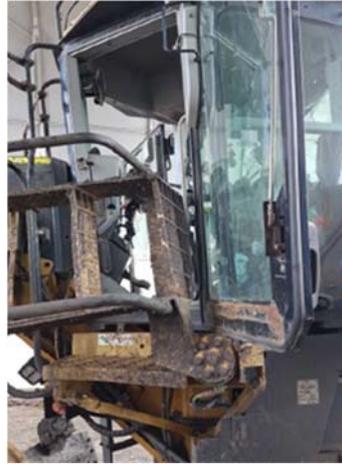
Fig 2: Partially raised access ladder
